# Habitation Investigation LLC

## Home Inspection Report

Property address: XXXXXXXXX  
Columbus, Oh

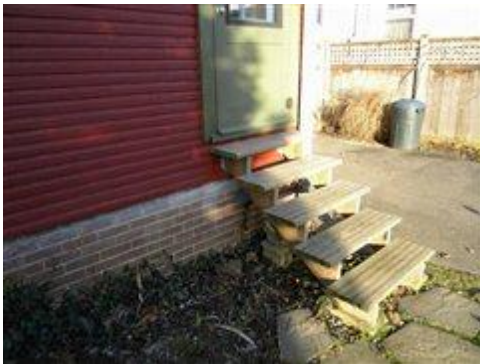
**Photo 16**

**4) 🛠️** Stairs with more than two risers had no handrail installed. This is a safety hazard. Handrails should be installed and be graspable handrails that your hand can completely encircle at stairs where missing, and as per standard building practices.

Trip hazard(s) exist at stairs due to non-uniform riser heights. Standard building practices call for riser heights not to vary more than 3/8 inch on a flight of stairs. At a minimum, the client(s) should be aware of this hazard, especially when guests who are not familiar with the stairs are present. Ideally a qualified contractor should evaluate and repair or replace stairs so all riser heights are within 3/8 inch of each other.

rear steps

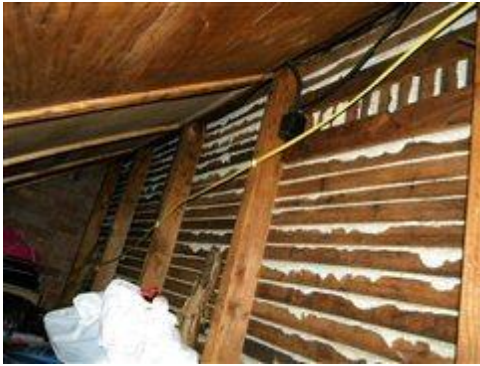
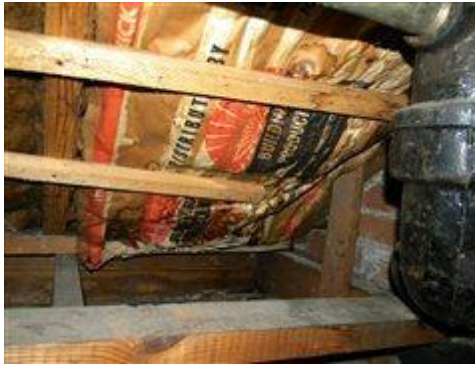
** Recommend placing insulation on the interior walls and removing it from the underside of the roof.

Also note that paper vapor barriers are often flammable and should be

placed against an interior wall.

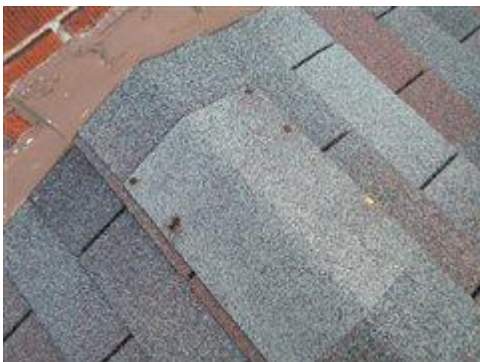
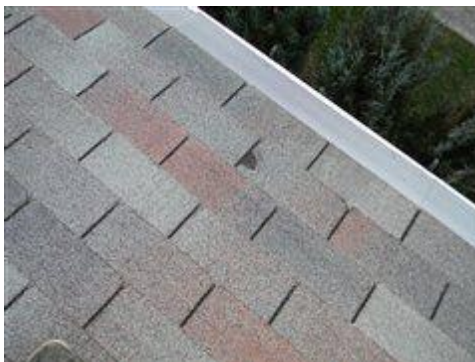
**11)** 🔧🔍💧 One composition shingle was damaged, deteriorated and should be replaced. Leaks may occur as a result. A qualified roofing contractor should evaluate and make repairs as necessary.

Also nail heads are exposed. Recommend applying sealant to help prevent leaks.

front porch roof

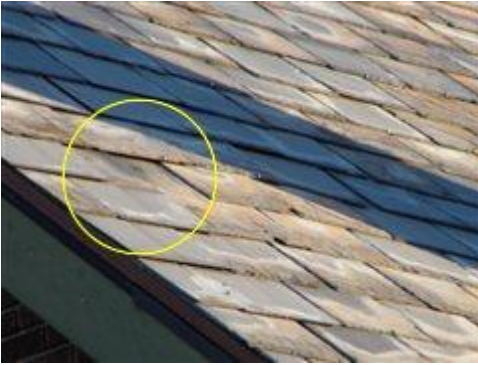
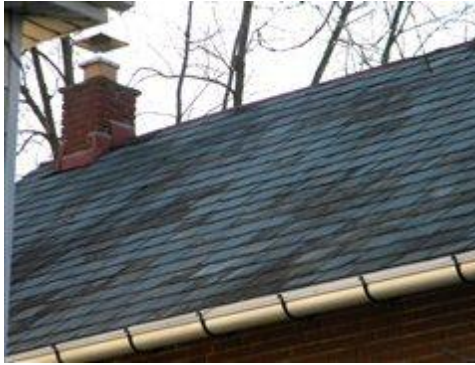
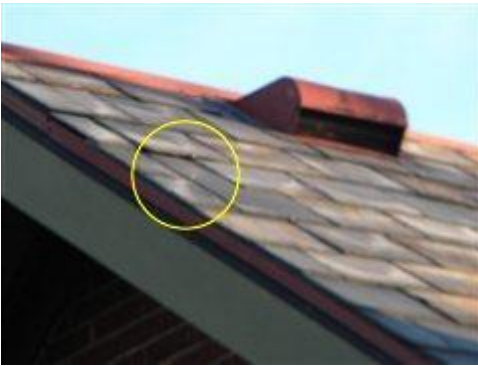
**12)** 🔧🔍💧 Two or more roofing slate tiles are missing, and should be replaced by a qualified roofing contractor.

There were also a few slate tiles that were chipped. Recommend repairs.

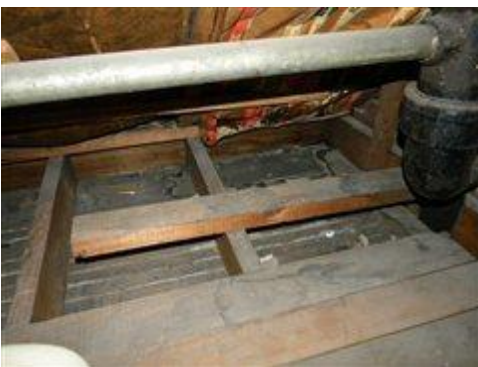
**Photo 31**

**13)** 🔧 Ceiling insulation was missing in some areas. Recommend installing insulation where missing for better energy efficiency.

Unable to determine the insulation in the upper portion of the attic space due to no access.

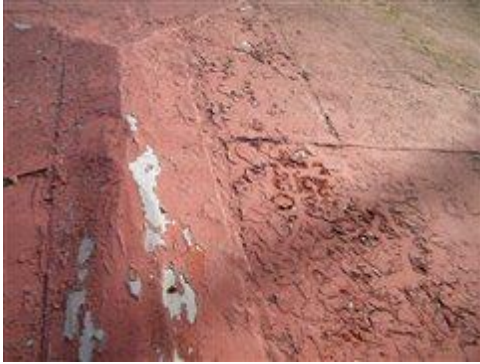
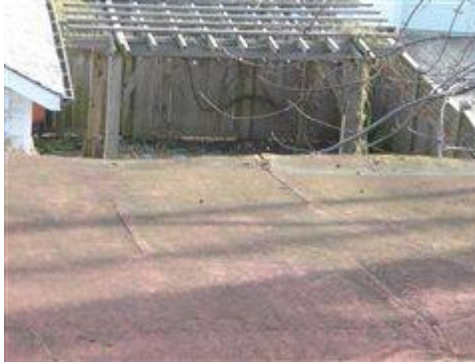
**14)** 🔧💧 Sections of the metal roofing had a failing paint finish. For example, peeling and/or missing paint. A qualified contractor should repaint metal panels where necessary.

Also one section near the edge was bent up, recommend bending down to help ensure proper rain run off.

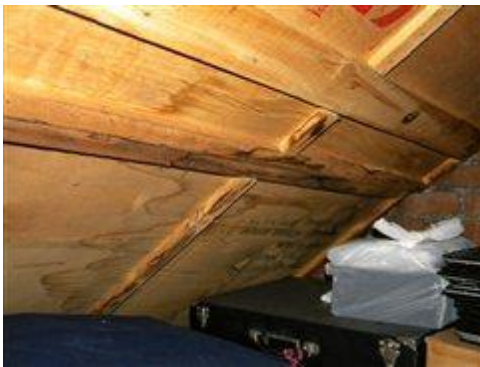
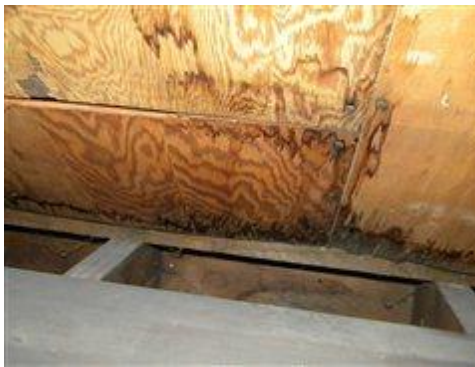
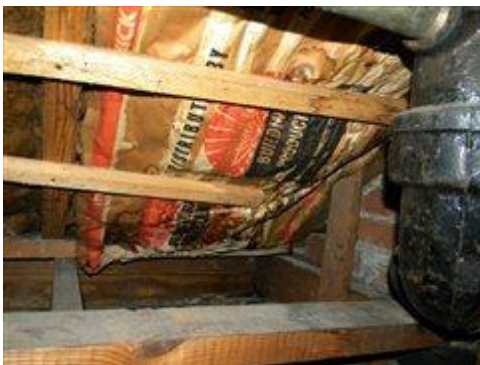
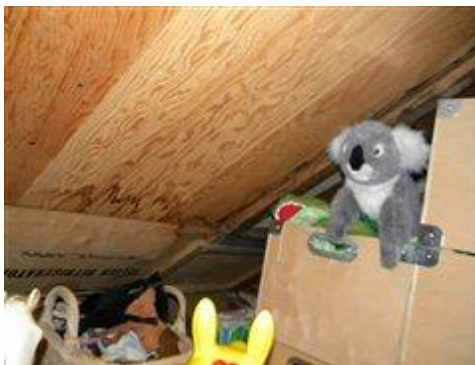
**15)** 🔍🏠 Stains were visible on the roof structure in one or more areas. These areas were dry at the time of the inspection. The stains may be caused by a past leak. Recommend asking the property owner(s) about past leaks. The client(s) should monitor these areas in the future, especially after heavy rains, to determine if active leaks exist. If leaks are found, a qualified roofing contractor should evaluate and repair as necessary.

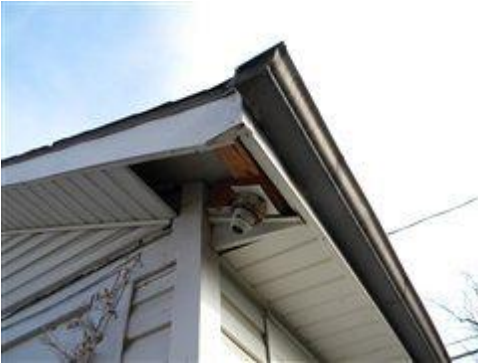
**Photo 34**

**21)** 🔧 Soffit had a missing section. Recommend replacing to help prevent animal entry.

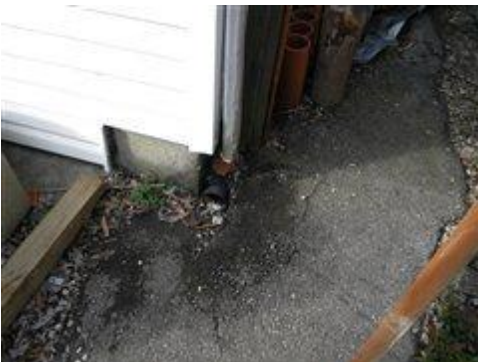
**Photo 37**

**23)** 🔧 Downspouts had no extensions, or have extensions that are ineffective. This can result in water accumulating around the structure's foundation, or in basements and crawl spaces if they exist. Accumulated water is a conducive condition to wood destroying insects and organisms, and may also cause the foundation to settle and possibly fail over time. Repairs should be made as necessary, such as installing or repositioning splash blocks, or installing and/or repairing tie-ins to underground drain lines, so rain water is carried at least several feet away from the structure to soil that slopes down and away from the structure.

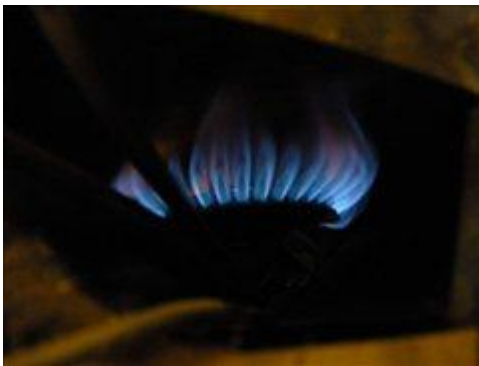
**Photo 17**

**32)** 📄 The flame on the water heater looked good.

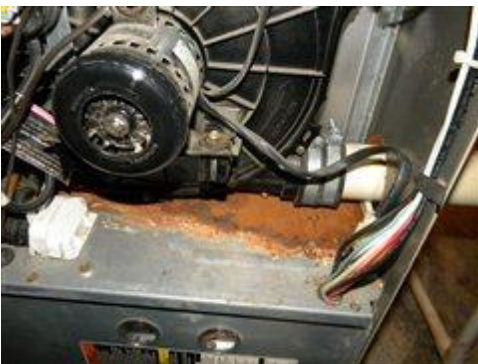
**Photo 19**

**36)** 🏠 Rust observed in the furnace cabinet. Active leaking did not occur during time of inspection. Recommend monitoring for leaks from the condensation line.

Also ask present owner for more details.

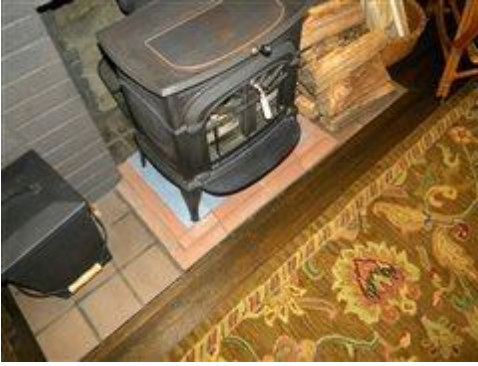
**Photo 39**

One or more fireplace or woodstove hearths are less than 18 inches deep. This is a fire hazard. At a minimum, non-combustible hearth pad(s) should be installed. Ideally the hearth(s) should be modified as

necessary or installed by a qualified contractor so they are at least 18" deep.

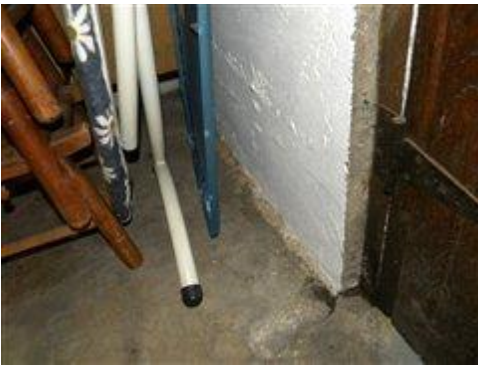
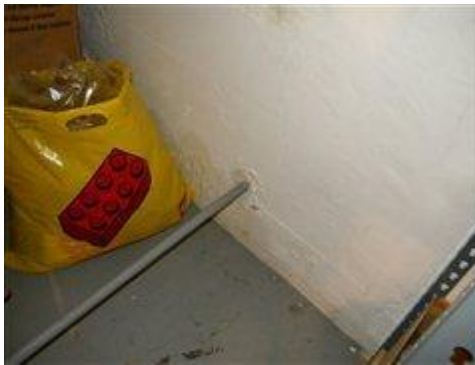
Evidence of prior water intrusion was found in one or more sections of the basement. For example, water stains and/or efflorescence on the foundation or floor, water stains at bases of support posts, etc. Accumulated water is a conducive condition for wood destroying insects and organisms and should not be present in the basement. The client(s) should review any disclosure statements available and ask the property owner(s) about past accumulation of water in the basement. The basement should be monitored in the future for accumulated water, especially after heavy and/or prolonged periods of rain. If water is found to accumulate, a

qualified contractor who specializes in drainage issues should evaluate and repair as necessary. Typical repairs for preventing water from accumulating in the basement include:

- Repairing, installing or improving rain run-off systems (gutters, downspouts and extensions or drain lines)
- Improving perimeter grading
- Repairing, installing or improving underground footing and/or curtain drains

Ideally, water should not enter the basement, but if water must be controlled after it enters the basement, then typical repairs include installing sump pump(s) or interior perimeter drains.

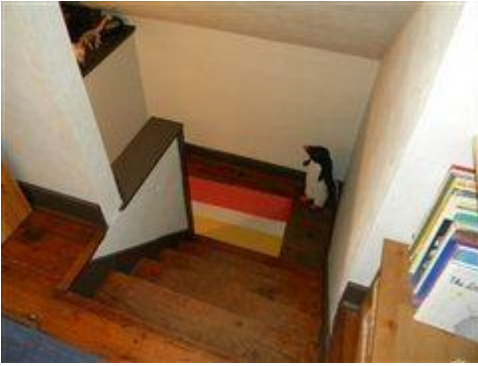
**Photo 24**

** Stairs with more than two risers had no handrail installed. This is a safety hazard. Handrails should be installed and be graspable handrails that your hand can completely encircle at stairs where missing, and as per standard building practices.

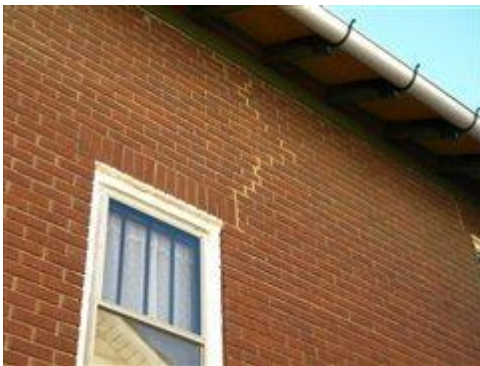
**Photo 4**  
repaired crack

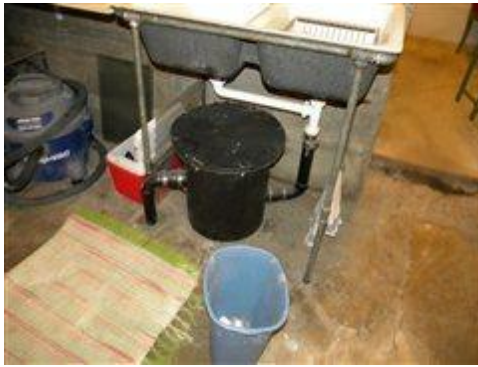
**Photo 22**

clay trap for rinsing off molds?

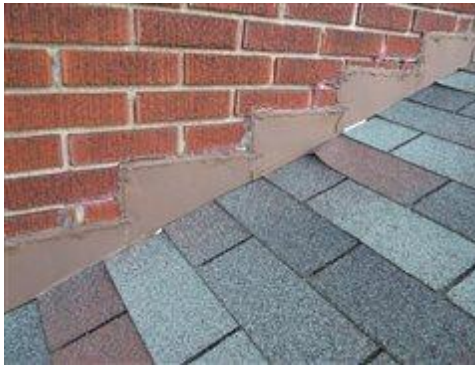
**Photo 40**  
proper flashing installation

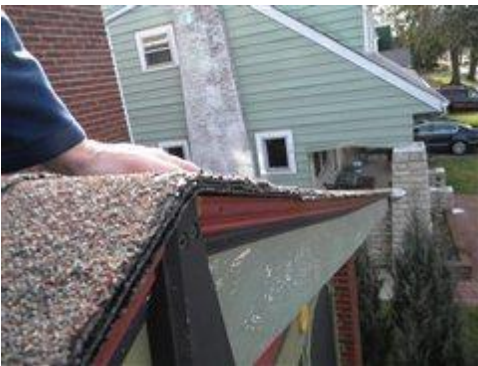
**Photo 43**  
one layer
